Manhole Inspection Summary

Manhole # S17GG_001MH

Insp Date: **4/13/09 2:44 PM**

Location Address: **REAR 1640 MORELAND**

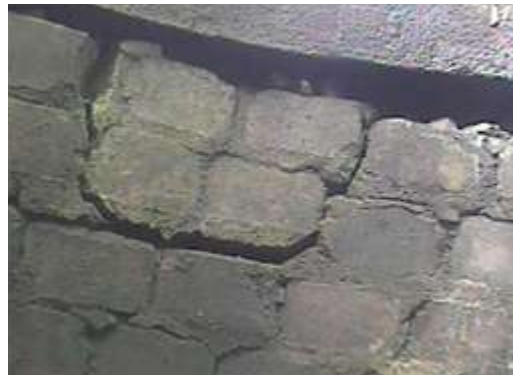
Defect 1

Condition: ☐ Sound ☒ **Cracked** ☐ Root Intrusion ☐ Loose Brick ☐ Deteriorated

CRACKED CORBEL

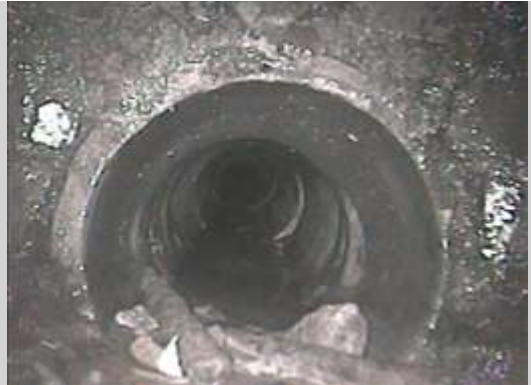
12 O'Clock Outflow

8 in. Circular Gravity Sewer
Pipe Out @ 12 O'Clock

Deposits: ☐ None ☐ Mud ☐ Sludge ☒ **Debris** ☐ Grease

Silt Depth: **2** (in.) Deposits Extent: **Light**
